Milwaukee County Courthouse – Façade Evaluation

PROJECT: Milwaukee County Courthouse
Façade Evaluation
Milwaukee, Wisconsin

DATE: June 8, 2010
FILE NO: 301164

FACADE EVALUATION

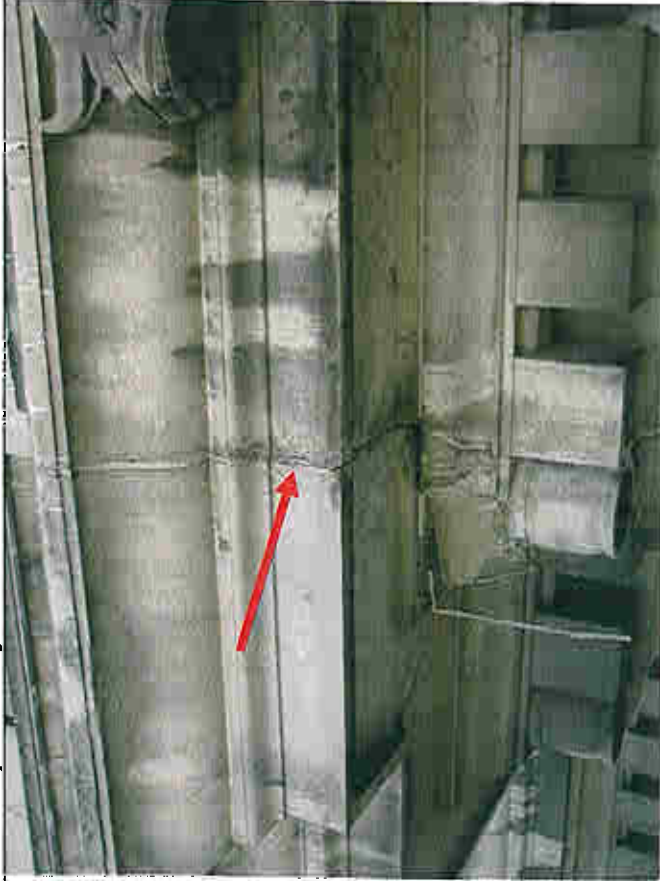
Photo #8 – Open seam and gap at fasteners of copper cornice cap

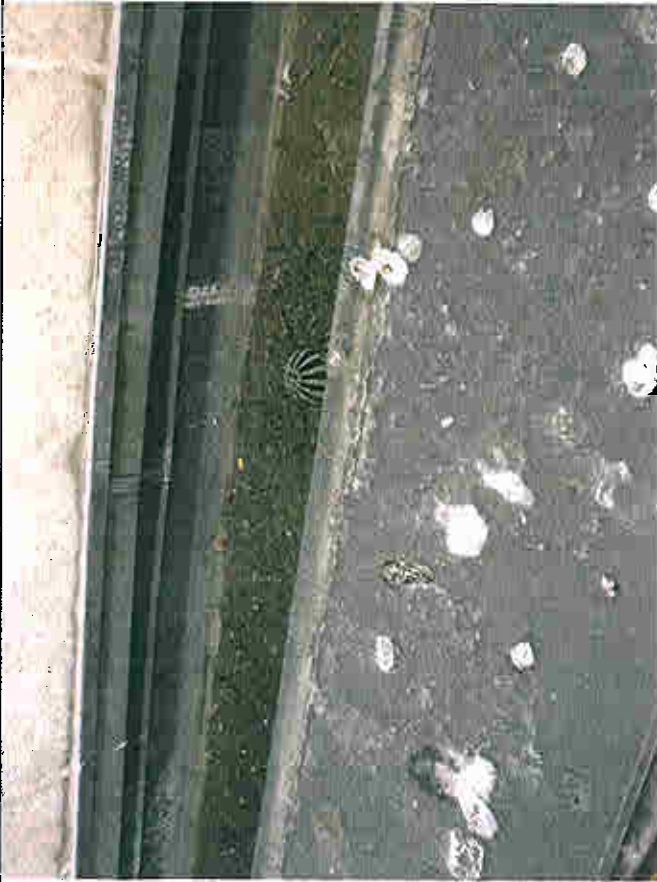
On March 9, 2010, and March 10, 2010, hands-on examination of the entire west elevation was performed via a 135' man lift. Examination from the roof level was also conducted on March 10, 2010. Debris was observed in the copper gutter, above the cornice, which clogged the roof drains (Photos #20 - #23). Cracks, spalls, open mortar joints, and previous repairs were observed (Photos #24 - #29). Areas of loose limestone were removed.

Photo #22 – Standing water in west gutter

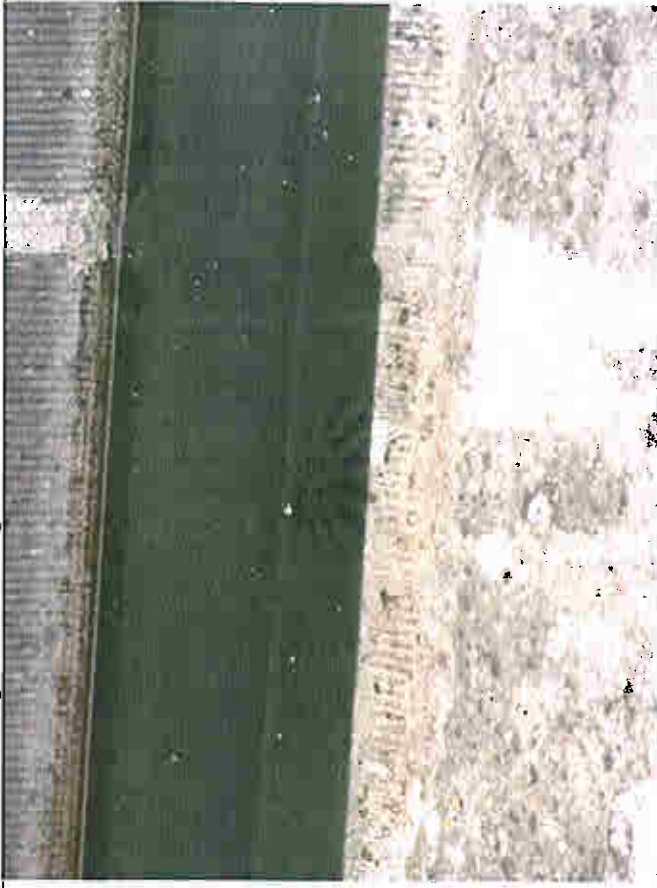
Photo #23 – Bird's nest in west gutter

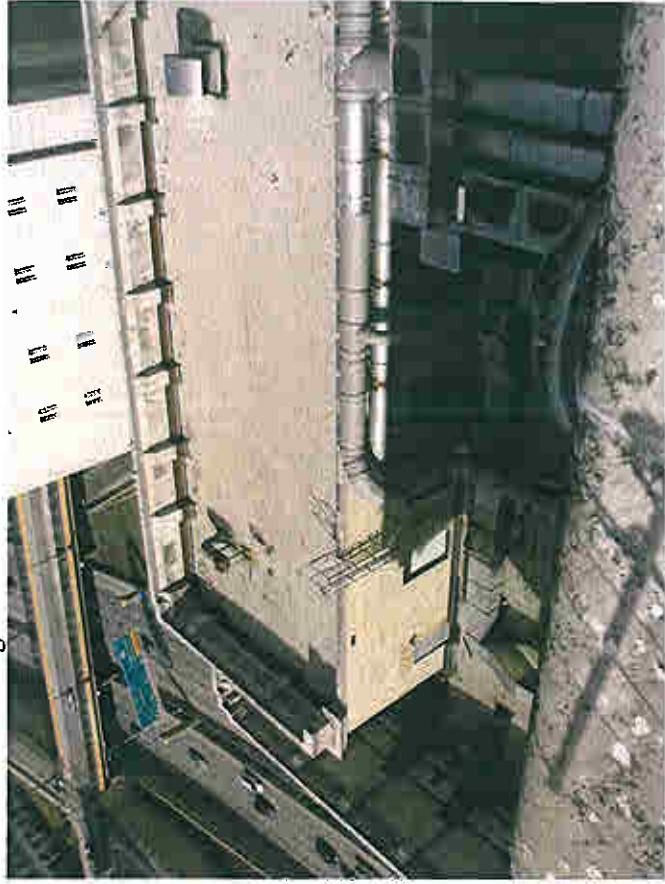
On March 15, 2010, visual examinations were performed from the ground level of the south, east, and north elevations. Further examination was performed from the roof level (Photos #30 - #32).

Photo #31 – Back of parapet

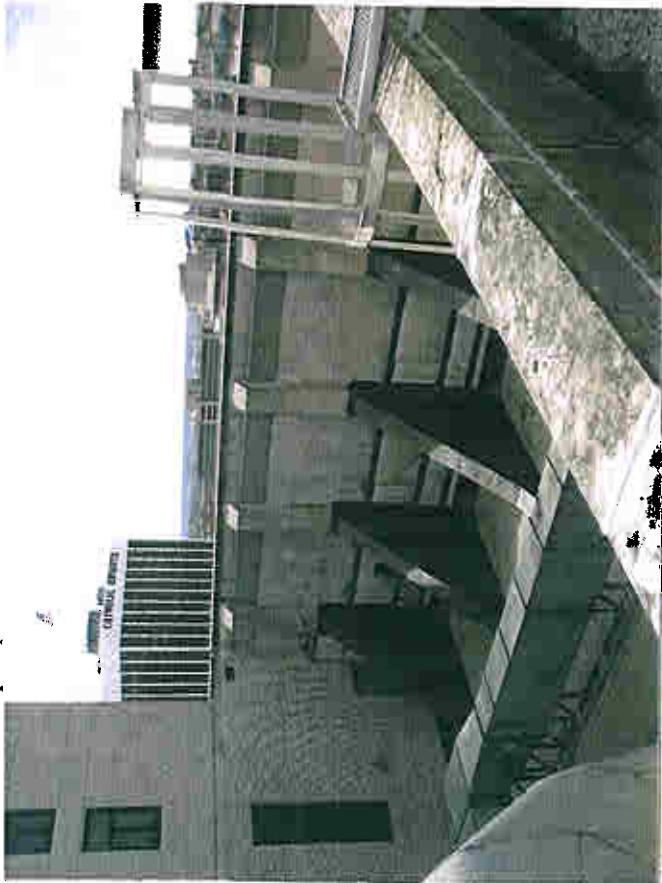
Photo #32 – Scupper and downspout

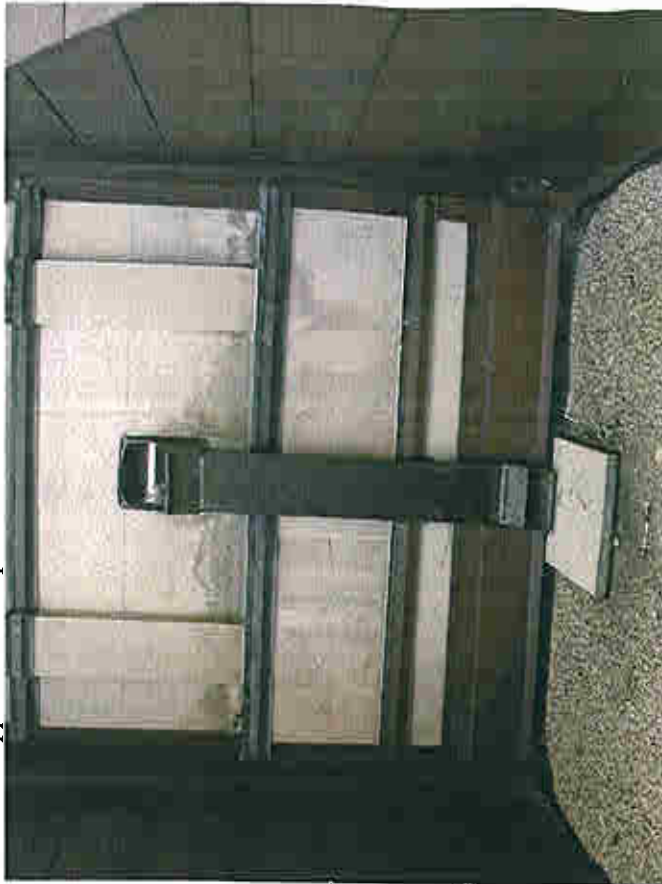
1. Open and debonded limestone mortar joints (Photos #33 - #36).
2. Application of sealant at limestone joints most notably at the cornice (Photos #37 - #38).
3. Copper gutter and cornice cap with open solder joints, open holes at fasteners and previous patches (Photos #39 - #41).
4. Debris in copper gutter (Photo #42).

Photo #33 – Open mortar joint
